# **Process Stability Improvement on a Dual Frequency Etch Tool by Means of Plasma Parameters**

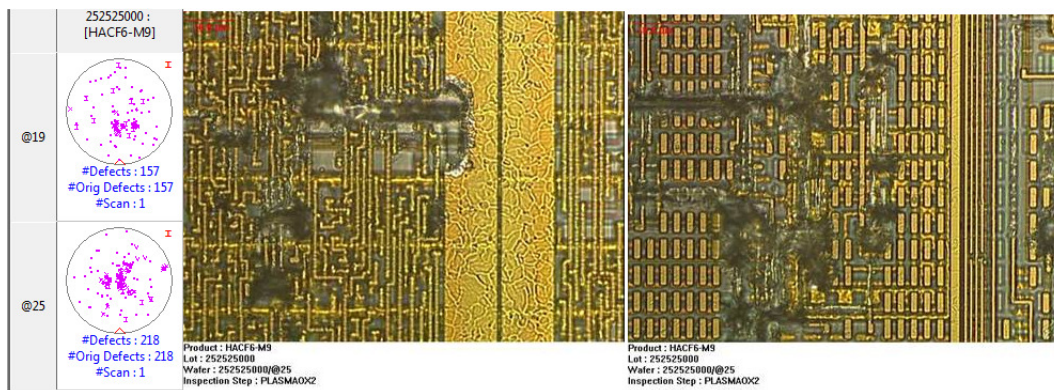
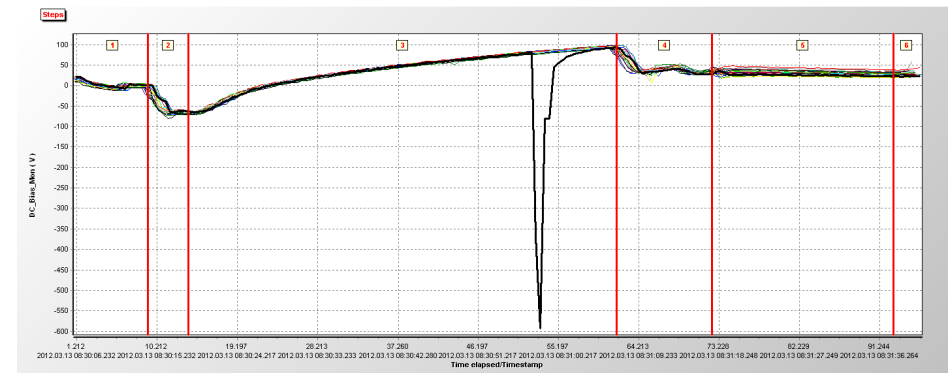
For years we are experiencing different types of plasma instabilities on a dielectric dual frequency etch tool (27/2 MHz). Sometimes the plasma is recovering, the tool is not aborting but the wafer shows arcing damage. Sometimes the plasma is just dropping out...

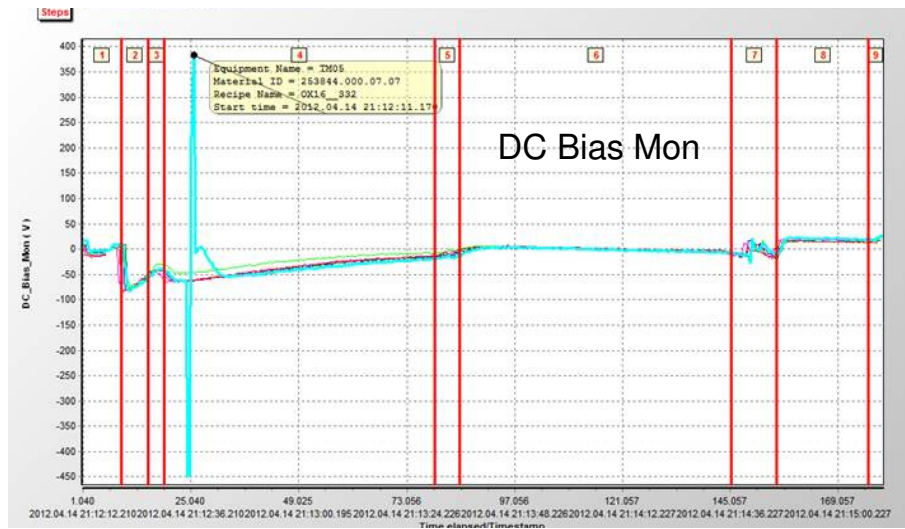
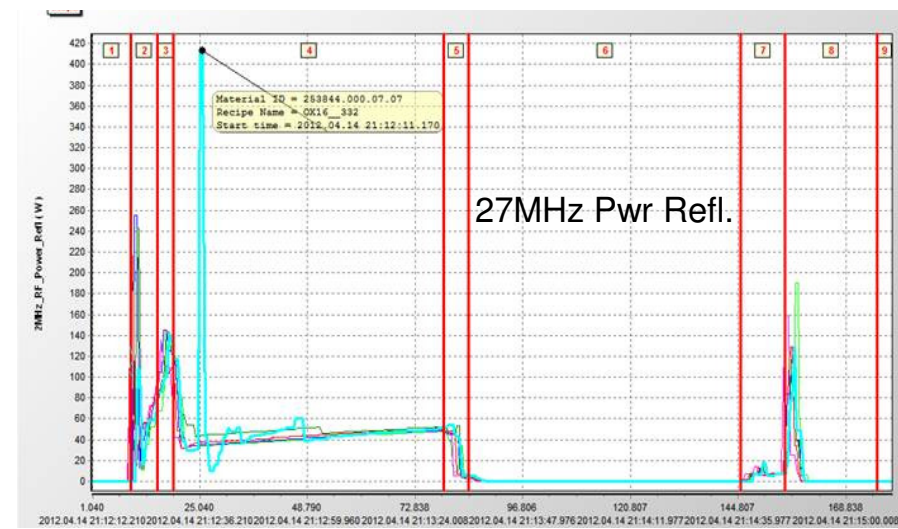
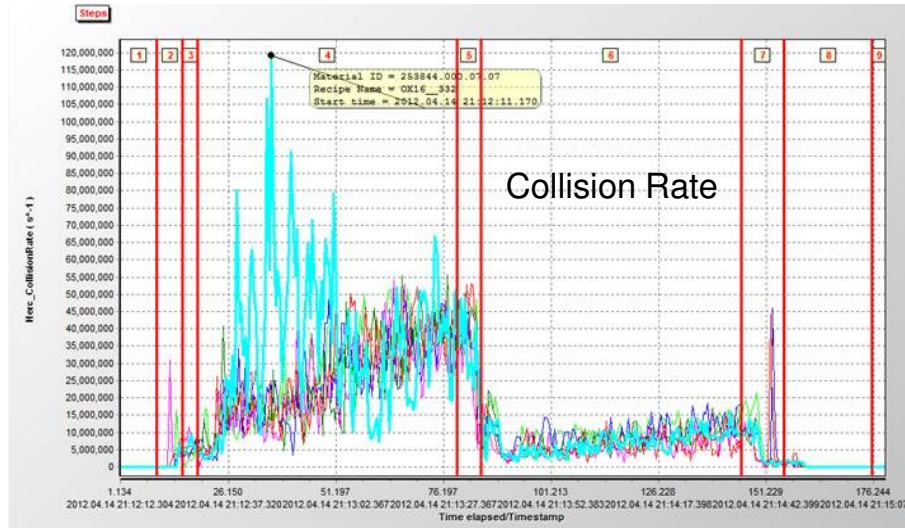
Plasma instabilities sometimes result in plasma dropout, sometimes it's recovering like in this case...but plasma parameters like collision rate show a remaining medium-term plasma instability and the product often is damaged without any tool alarm.

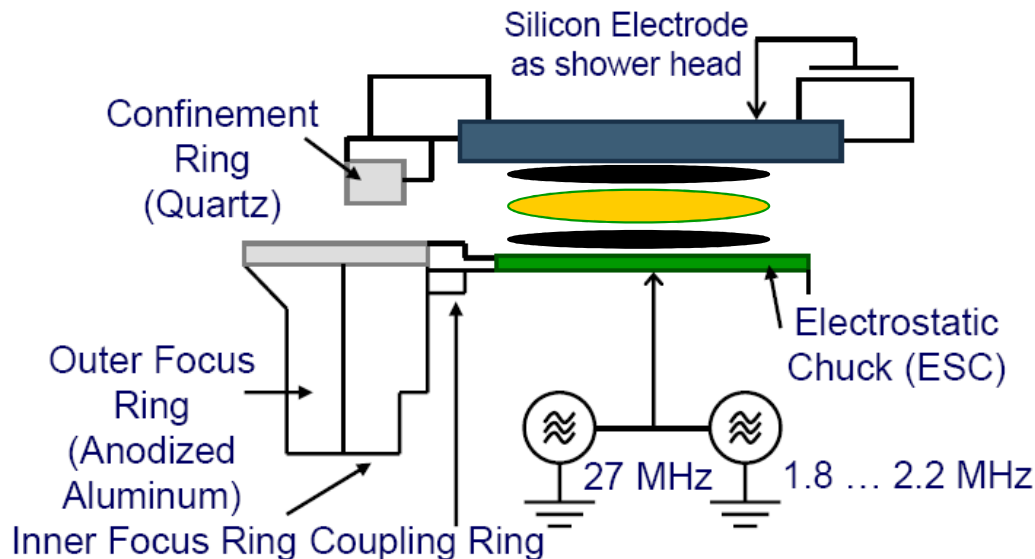
- ◆ 27 MHz is responsible for plasma generation
- ◆ 2 MHz is controlling the sheath and is influencing the ion acceleration (DC Bias)
- ◆ 2 MHz nearly no influence on plasma generation (⇒ 27 MHz)
- ◆ the higher the 2 MHz power the smaller the plasma bulk, sheath is filling mostly the gap
- ◆ the smaller the pressure, the smaller the bulk
- ◆ the smaller the gap, the smaller the bulk

- ◆ choosing the 2MHz power too high, the 27 MHz power is too small to generate an adequate plasma bulk for a stable plasma sustainment
- ◆ situation is getting worse with smaller gap, e.g. caused by new parts inside the chamber
- ⇒ process gets instable and small influences can cause plasma dropout

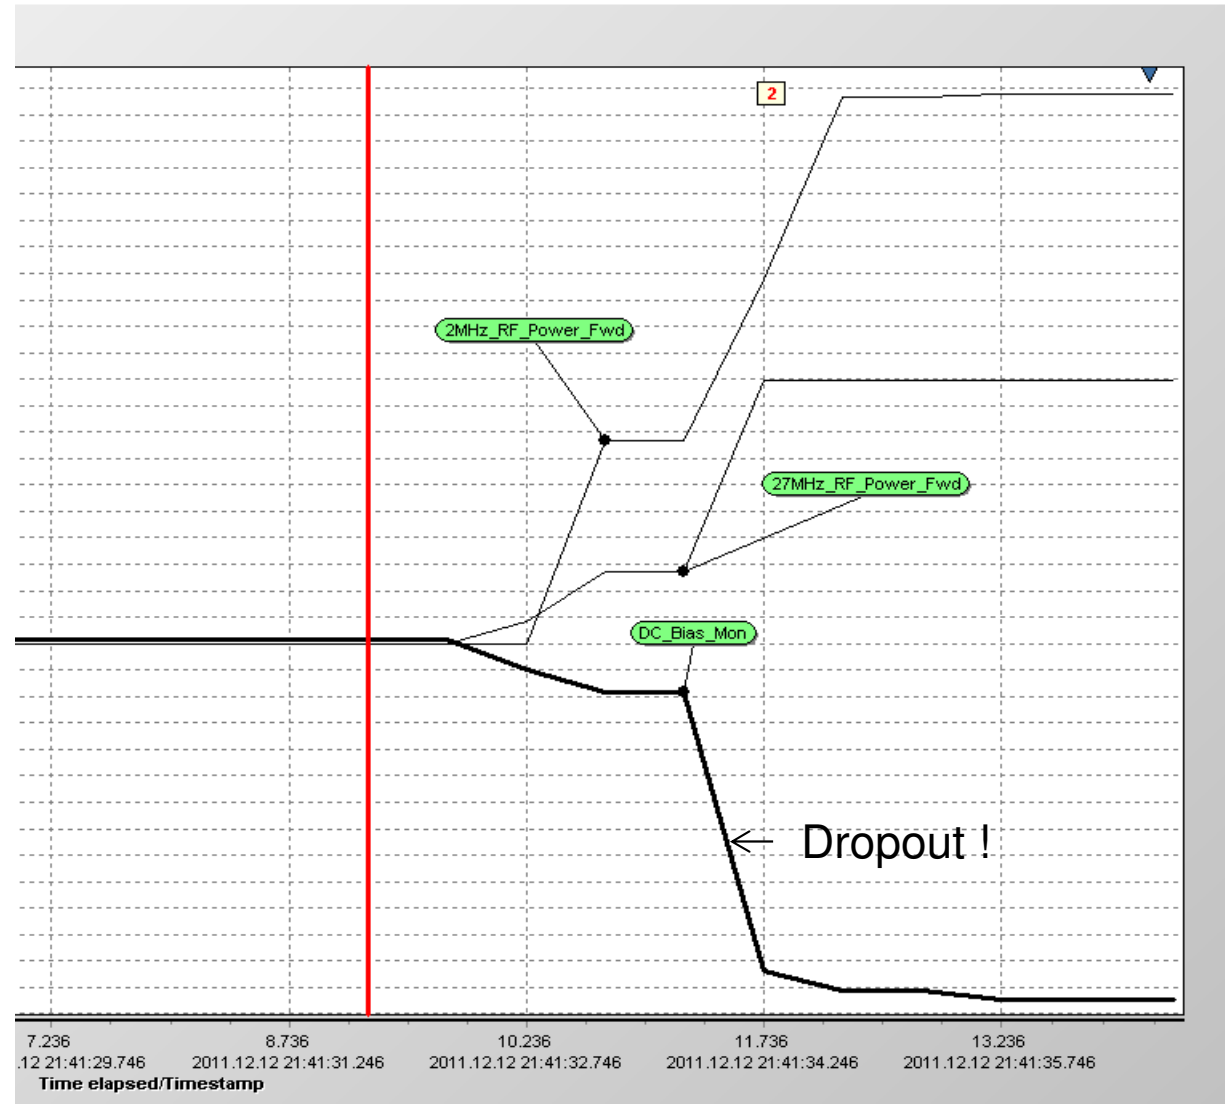
- ◆ process was setup by supplier / according to BKM
- ◆ strange : the 2MHz is ramped to max value before the 27MHz power
- ◆ most aborts are happening in step 2 during this ramp
  - ◆ 27MHz power is not able to provide stable plasma conditions as fast as needed
  - ◆ 2MHz starts to pull ions out of the bulk and is increasing the sheath
  - ◆ bulk is collapsing, plasma dropout

- ◆ a must : ramp 27MHz first & faster then 2 MHz power
- ◆ done by decrease in and delayed ramp of 2MHz power

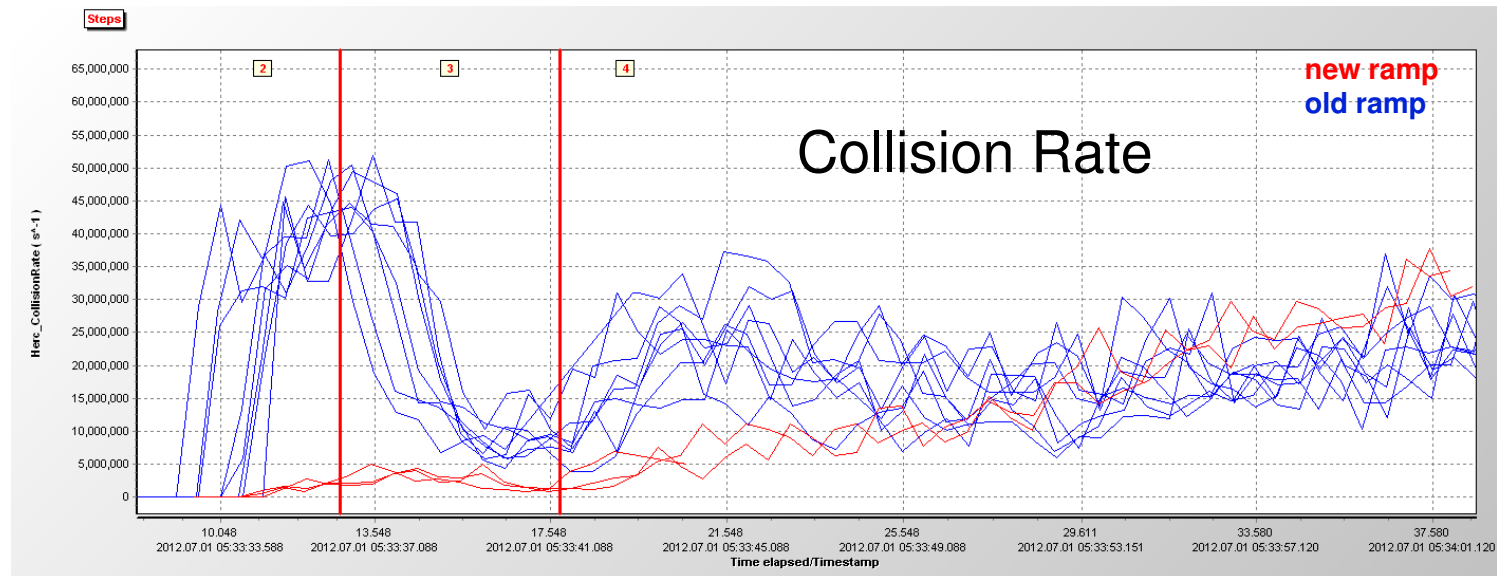
new ramp is

- ◆ more stable during ignition
- ◆ showing more medium-term stability
- ◆ showing no aborts in the last months
